# LKB-ADDs, Plus Schematic

DDQ12/LA1901 Schematic with Capture CIS and Function field  
uFCPGA Banias  
01-02-2004  
REV: 3.0

Title		
Cover Sheet		
Size	Document Number	Rev
	DDQ12/13/01 with LA-1901	3.0
Date:	Wednesday, January 07, 2004	Sheet 1 of 59

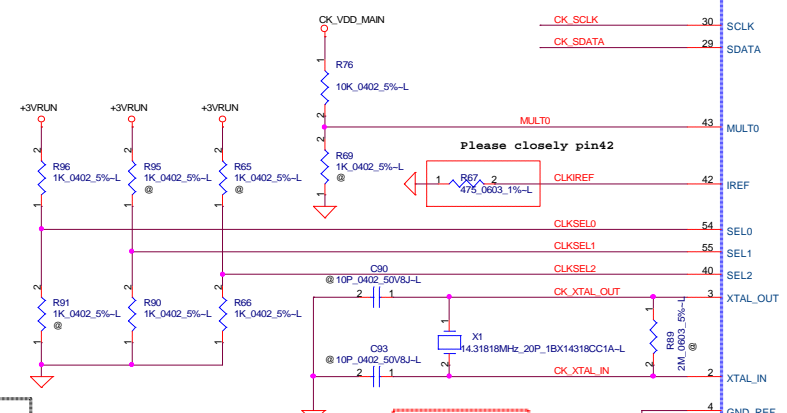
Place crystal within 500 mils of CK408

W=20 mils

Place near CK408

S2	S1	S0	CPU	3V66[0..4]	3V66_5/66IN	
1	0	0	66	66IN	66	Input
1	0	1	100	66IN	66	Input
1	1	0	200	66IN	66	Input
1	1	1	133	66IN	66	Input
0	0	0	66	66	66	Input
0	0	1	100	66	66	Input
0	1	0	200	66	66	Input
0	1	1	133	66	66	Input
Mid	0	0	Hi-z	Hi-z	Hi-z	
Mid	0	1	TCLK/2	TCLK/2	TCLK/2	
Mid	1	0	Reserve	Reserve	Reserve	
Mid	1	1	Reserve	Reserve	Reserve

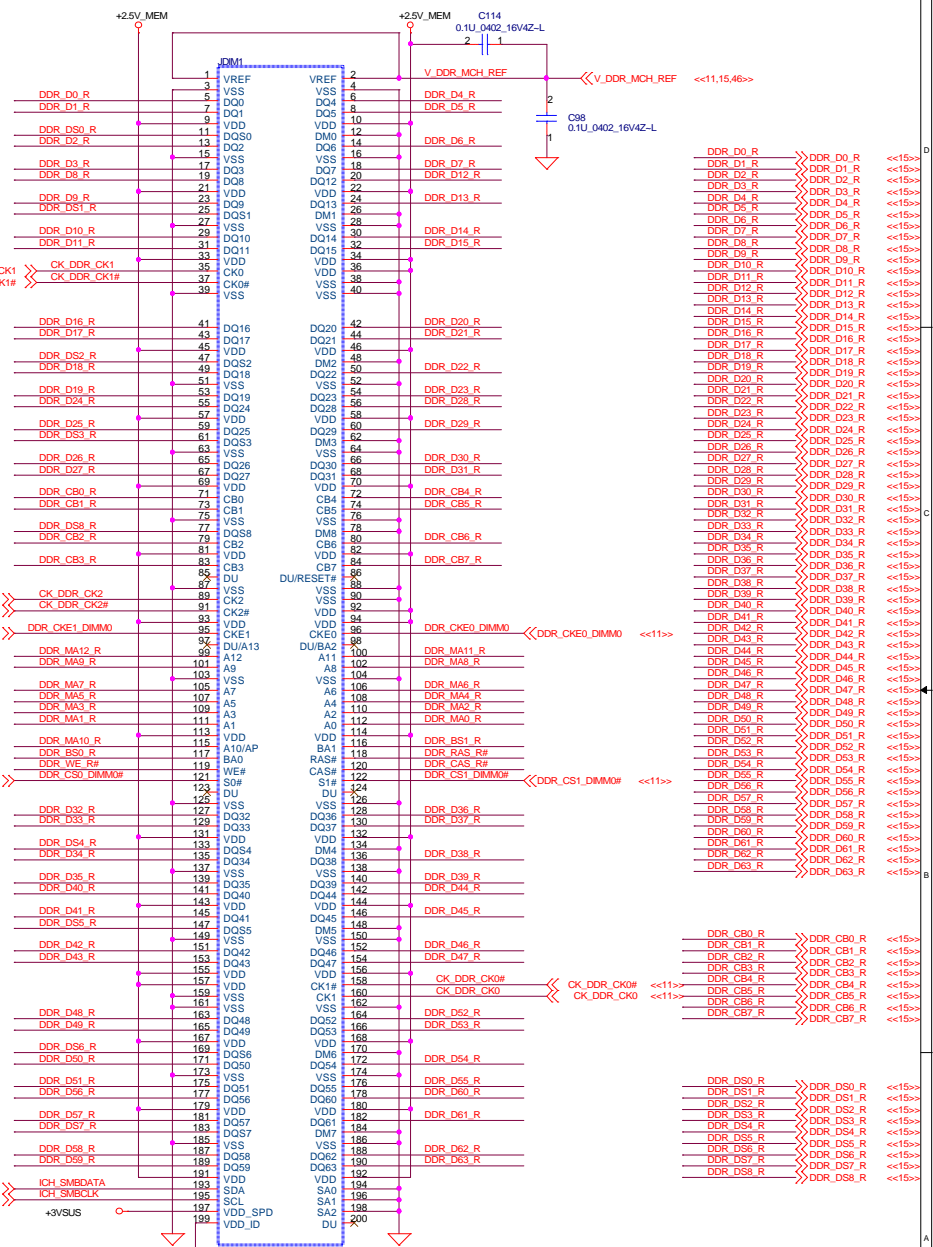
Title			
<b>DDR-SODIMM SLOT1</b>			
Size	Document Number	Rev	
	<b>DDQ12/1/01 with LA-1901</b>	<b>3.0</b>	
Date:	Wednesday, January 07, 2004	Sheet	14 of 59

**Layout Note:**  
 Place these resistor  
 closely DIMM0, all  
 trace length<750 mil

**Layout Note:**  
 Place these resistor  
 closely DIMM0, all  
 trace length  
 Max=1.3"

**DIMM0 STANDARD**  
 R119  
 10K\_0402\_5%-L

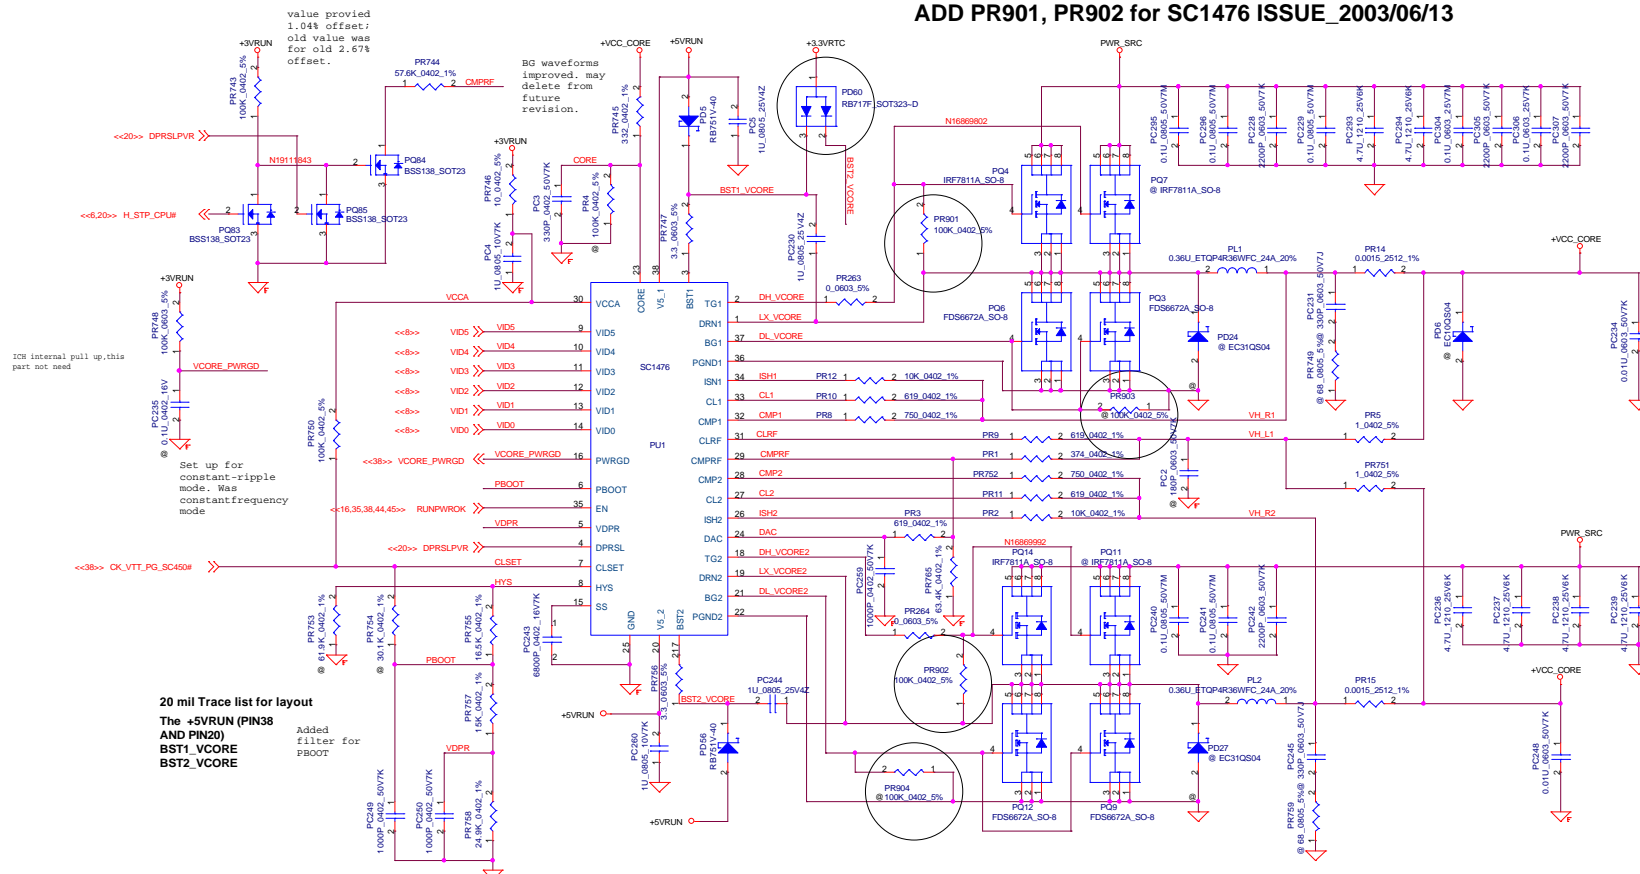
ADD PR901, PR902 for SC1476 ISSUE\_2003/06/13

IOB internal pull up, this part not need

Set up for constant-ripple mode. Was constant frequency mode

20 mil Trace list for layout  
The +5VRUN (PIN38 AND PIN20)  
BST1\_VCORE  
BST2\_VCORE

V I D						Vcore
VID 5	VID 4	VID 3	VID 2	VID 1	VID 0	V
0	1	0	1	1	1	1.340
0	1	1	0	0	0	1.324
0	1	1	0	1	0	1.292
0	1	1	1	0	0	1.260
0	1	1	1	0	1	1.244

100 mil Trace list for layout

- DH\_VCORE
- LX\_VCORE
- DL\_VCORE
- DH\_VCORE2
- LX\_VCORE2
- DL\_VCORE2
